ARINAGA SEWAGE OUTFALL (CANARY ISLANDS – SPAIN)

Summary

The new Arinaga sewage outfall (Gran Canaria Island, Spain) goes through the existing infrastructure in the port in order to reach a great depth to avoid exposing the pipe to wave action. This is achieved thanks to an ingenious idea that allows the pipe to pass through the precast caisson. The rest of the pipeline was placed safely on the seabed at a significant depth.

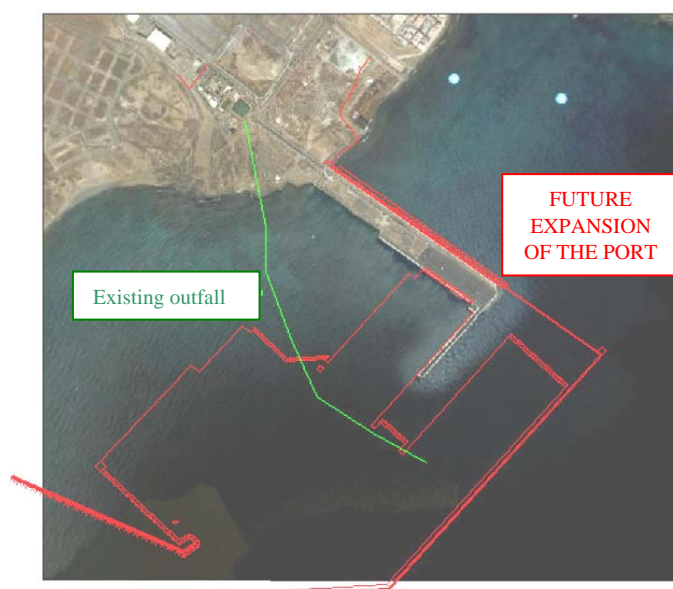
Figure 1. Sketch of the initial outfall position and the future port expansion

The project consisted of constructing a new outfall (of HDPE, 900 mm outer diameter) for the sewage treatment plant to prevent the direct discharge of sewage water inside the harbour after the future expansion of the Port, as can be seen in the following figure:

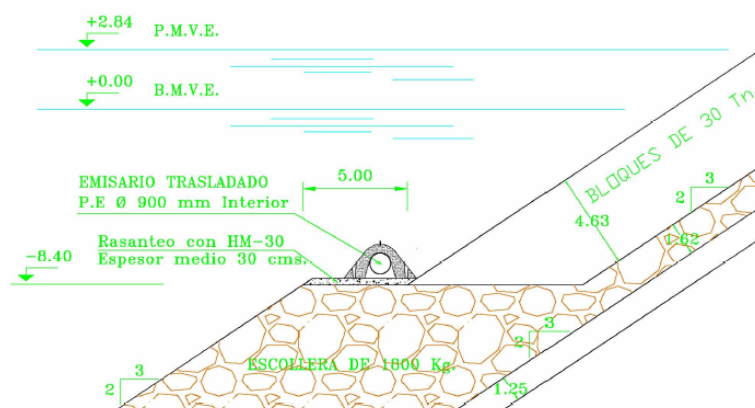
Figure 3. Typical section of the outfall in the original project

The original project (which served as the basis for the construction tender) situated the outfall pipe on the outside berm of the existing breakwater, directly placed on the armour stone. This solution created a hazardous situation due to the great turbulence generated by the waves hitting against the breakwater which could lead to displacements of

Running parallel to the breakwater (see figures 2 and 3) on the berm created several disadvantages:

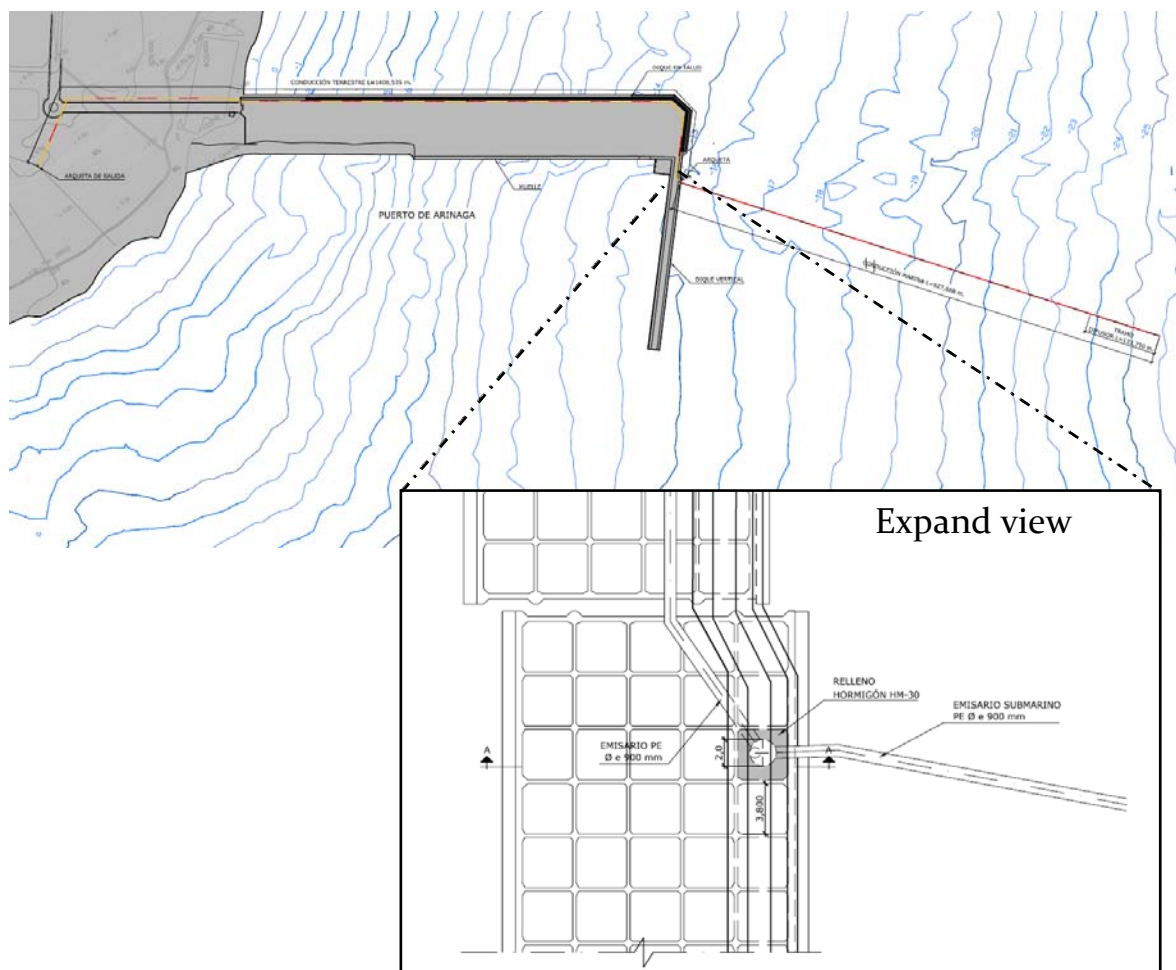
Figure 4. Typical section of the outfall in the original project

The uniqueness of the project lies in using a cell from the breakwater caisson as an outlet chamber. (See figure 4).

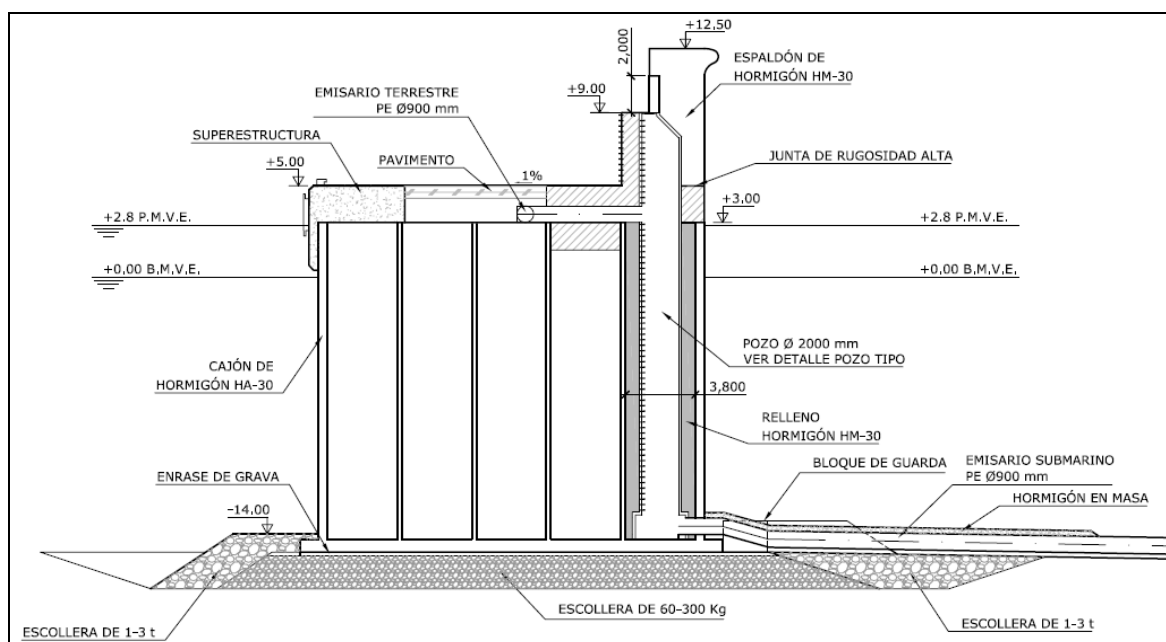
Figure 5. Typical section of submarine outfall caisson, chamber and outflow

Temporarily dismantling of the crown wall was necessary for the construction work and allowed for access to the cell closest to the sea. Upon rebuilding the crown wall, a vented manhole was integrated into the structure allowing air to escape easily (as seen in the following figure).

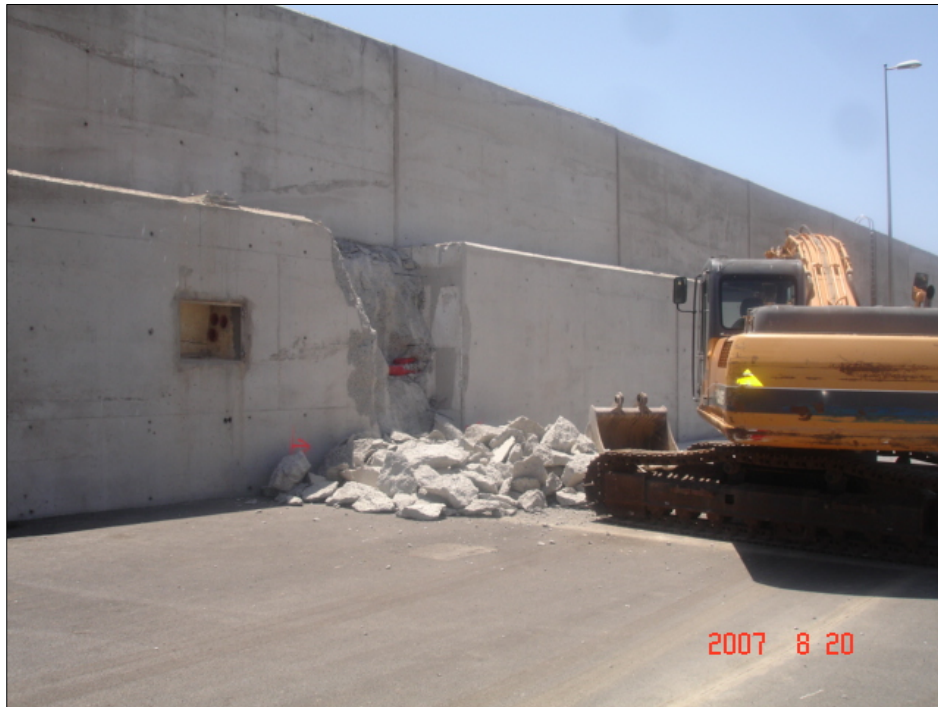
Photograph 1: Start of the demolition of the breakwater crown wall

The pipe was protected with concrete in low-covered areas onshore. This section was executed with due caution without causing any additional problems. The most delicate part completed using onshore resources was demolishing the crown wall and creating the surge tank in the cell. These actions were carried out with due caution. A backhoe with a long arm was initially used to empty the caisson cell, but the results were very limited. A bivalve crane was later used with much better results.

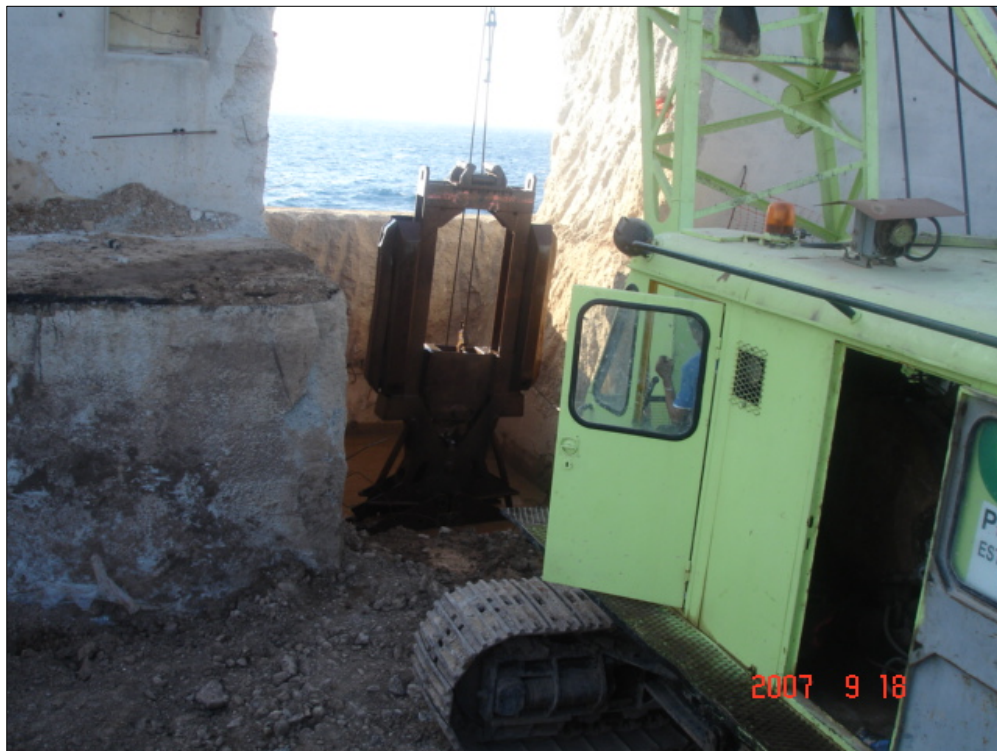
Photograph 2 Excavation of the caisson chamber

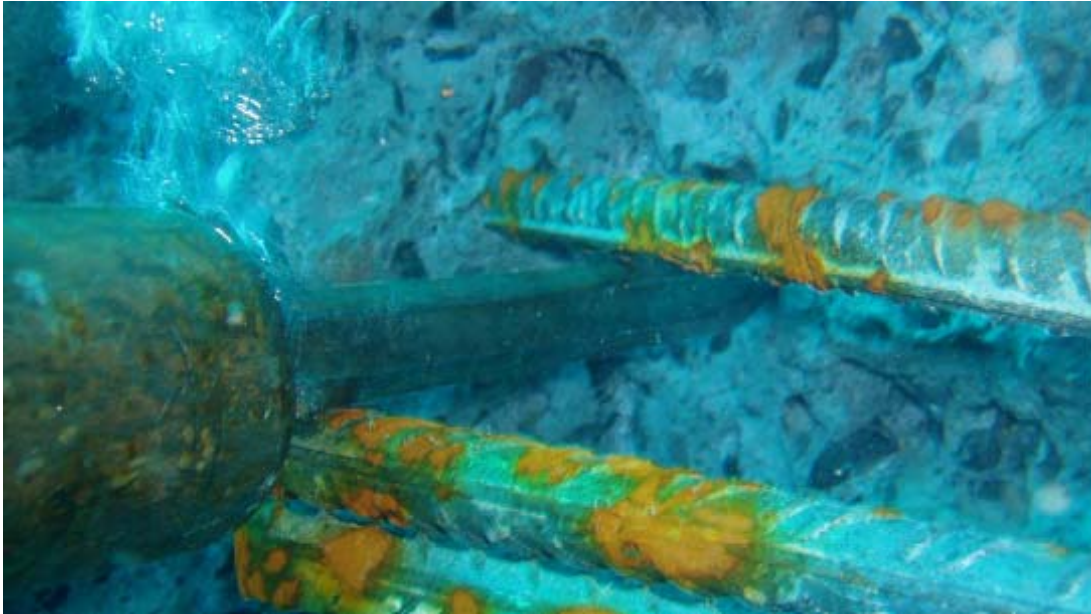
Photograph 3: Caisson perforation in the submerged area

One of the most complex jobs was opening the caisson cell in the submerged area to create a sea exit into for the underwater pipe. The crown wall protection blocs had been previously removed. This task was done with specialised divers. The cell was perforated 2x2 m. A photograph is shown below.

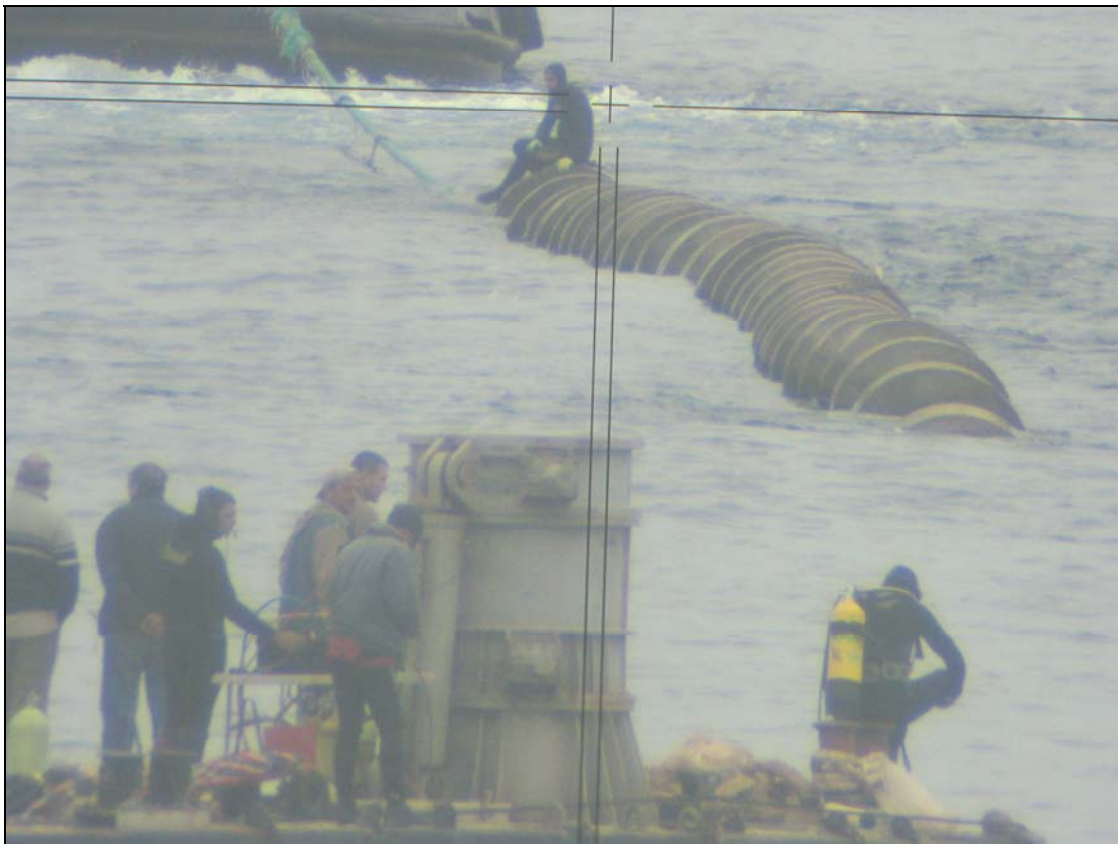
Photograph 4: Sinking the outfall

The pipe was welded at facilities on the port and it was stored there. Despite this, two storms occurred while the pipe was being stored at the port which damaged it. One of the sections even sunk to the seabed and; therefore, the pipe had to be refloated and repaired, removing all of the existing ballast weights. Despite these disadvantages, the polyethylene proved to be a very suitable material as it is resistant and adapts to the construction requirements.

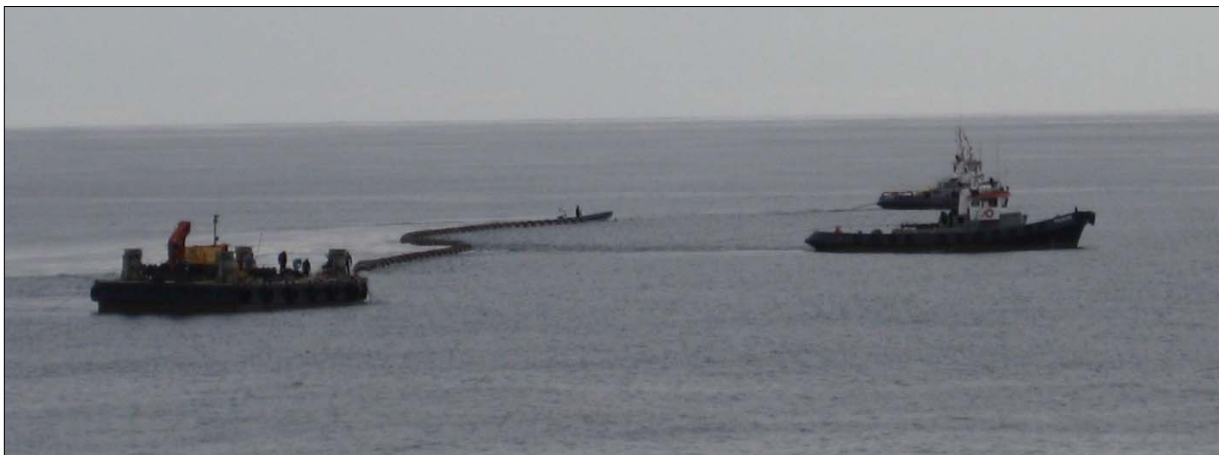
Photograph 5: Positioning the outfall for sinking

The process of taking the pipes to their final position was done via controlled sinking and progressive flooding. With this process, all of the phases the pipe must go through must be adequately calculated in order to guarantee its structural resistance.
